## Technical Service Bulletin – Incorrect Thermal Overload Installed & Power Cord Requirements

*Twister T2E Trimming Machine Electrical Overload, Supply Power Cord Updates and Extension Cord Use Reminders for 220-240V / 50Hz Markets*

April 14, 2026

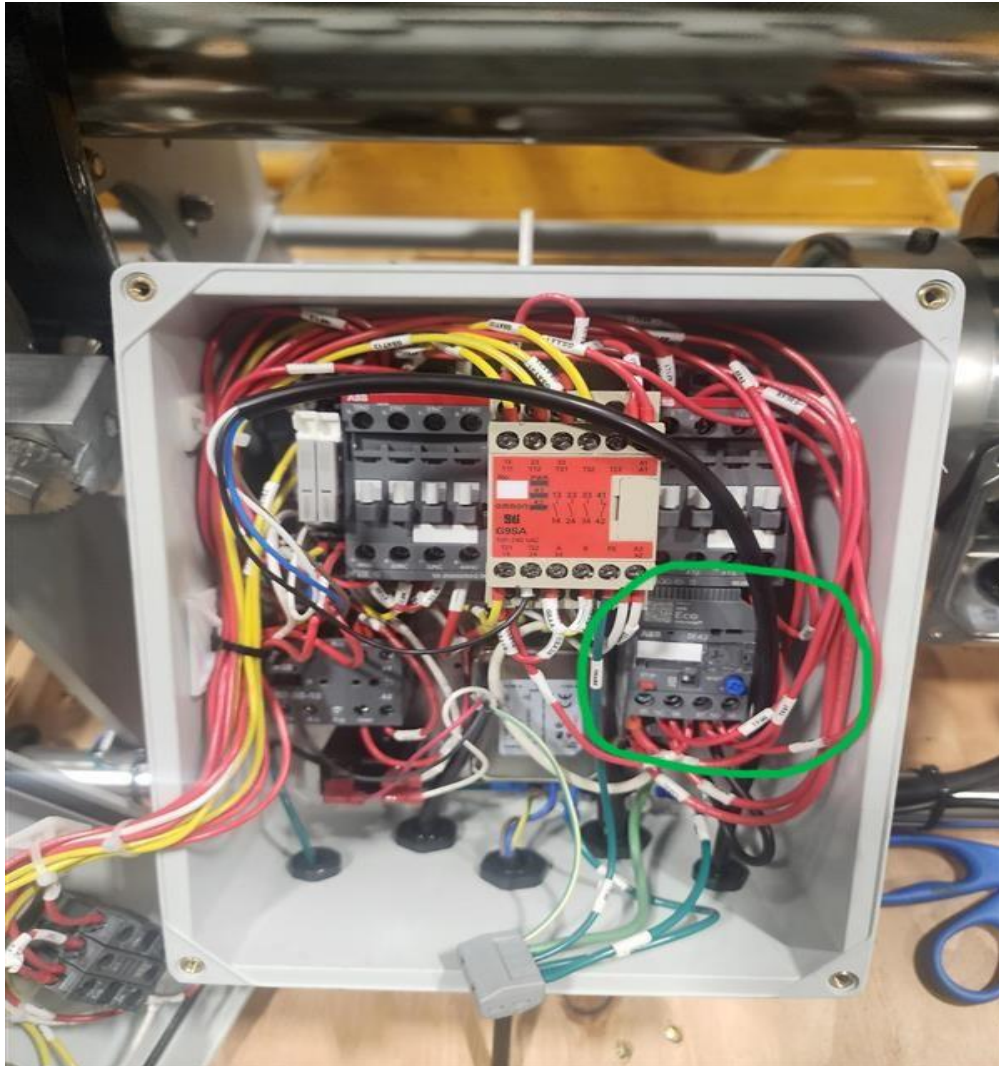
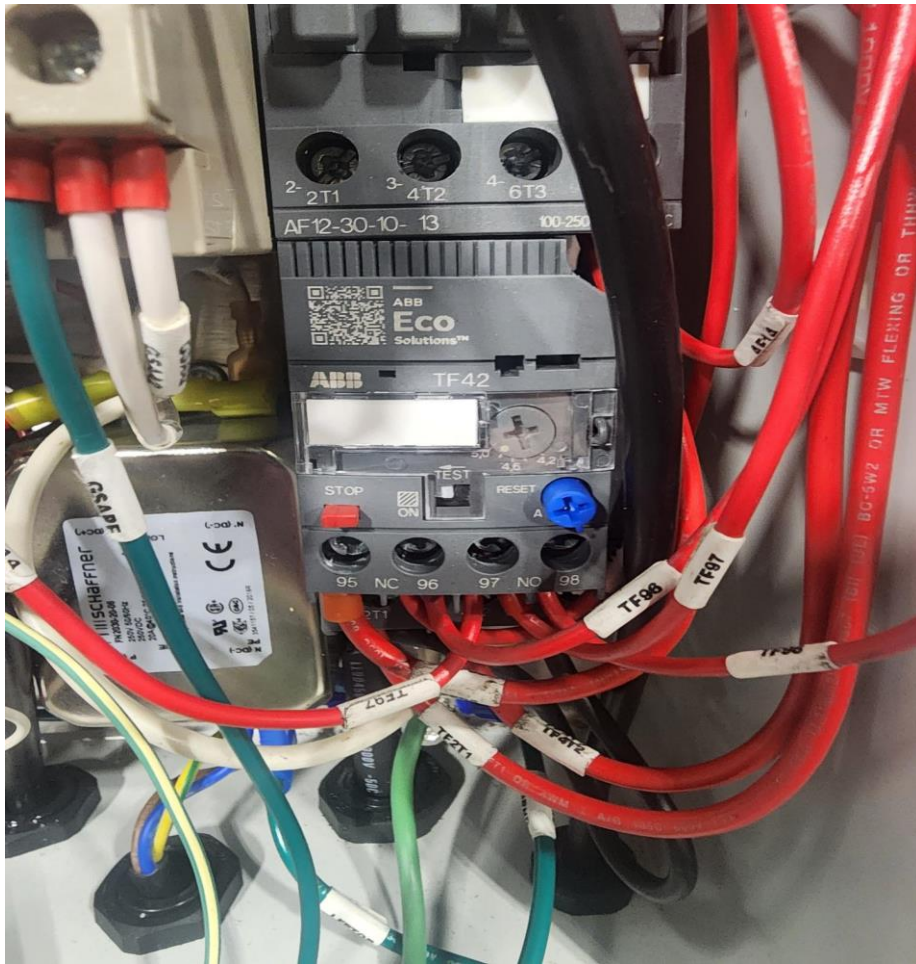
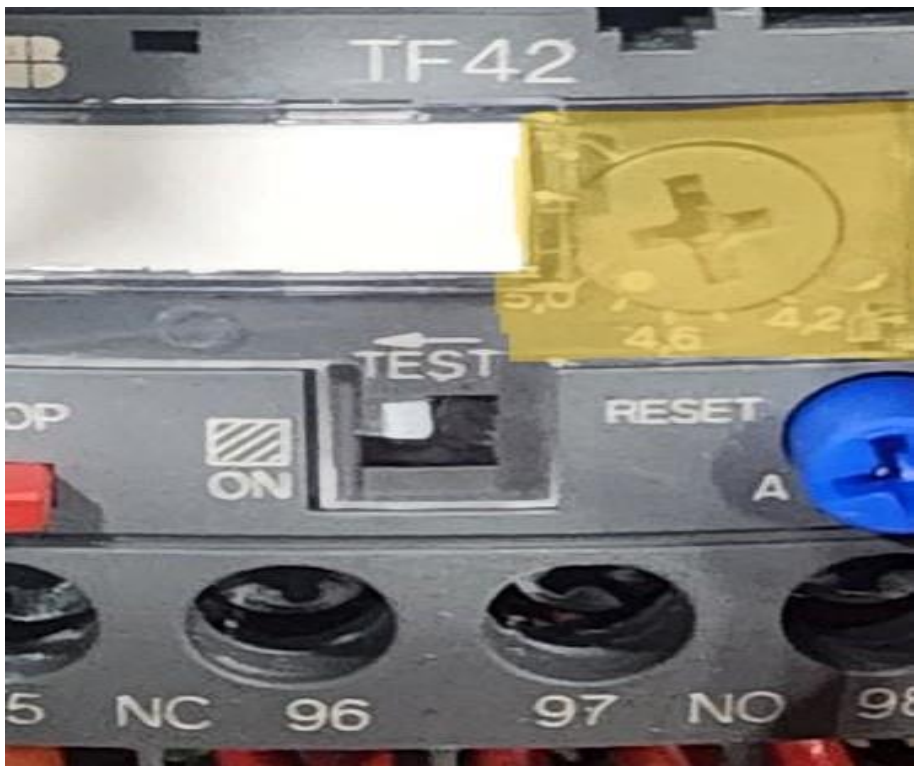
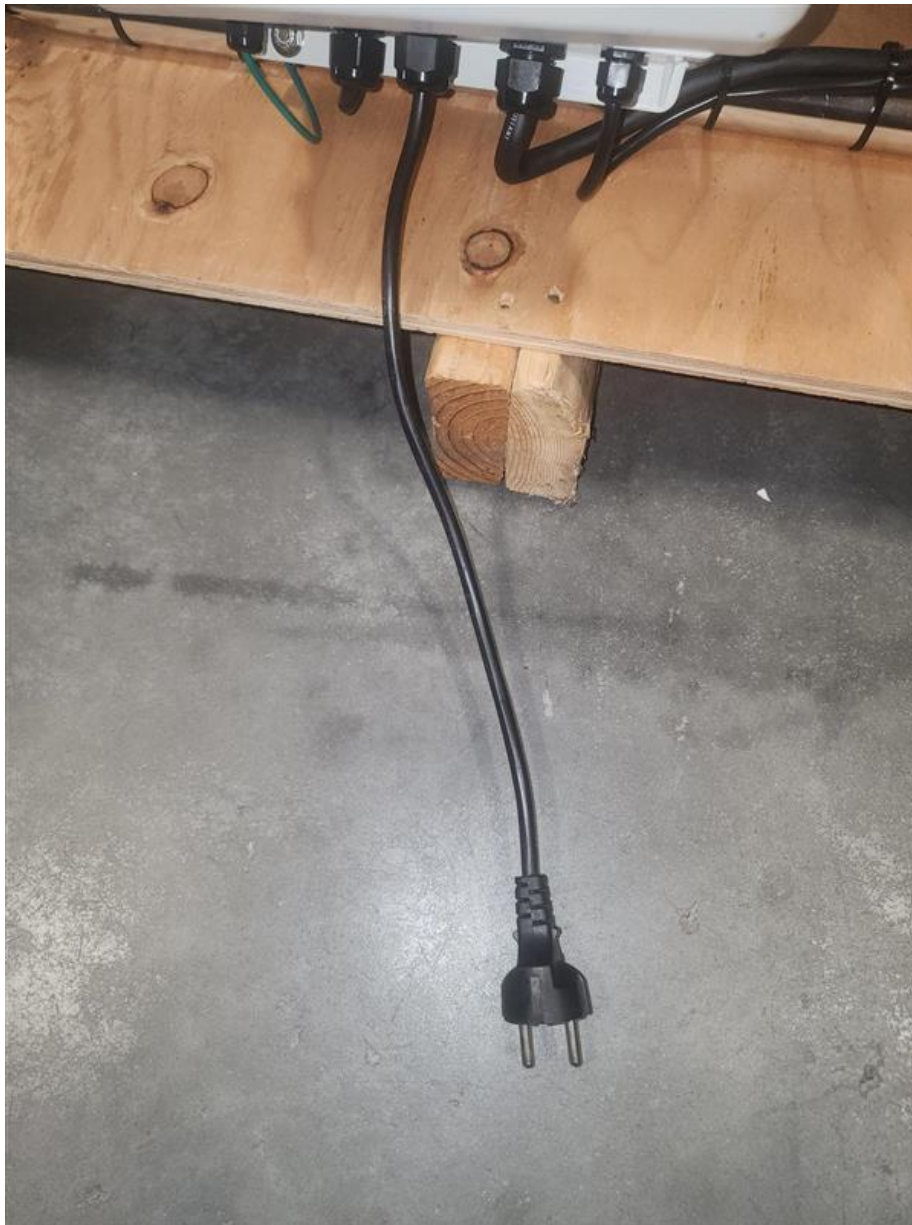
This technical service bulletin applies to certain Twister T2E Trimming machine operating in **220-240V / 50Hz** markets, including Europe, Australia, and New Zealand. Keirton has identified that some machines may have been fitted with an overload configuration that is rated too high for the intended electrical environment. This may allow the blade motor circuit to draw higher current than intended, increasing the likelihood of motor shutdown issues, failures, and capacitor damage. In addition, these same machines may have been fitted with thin gauge power supply cords, 1mm<sup>2</sup> (18 AWG), vs the required 3.3mm<sup>2</sup> (12 AWG)

1. **Verify components:** Contact Keirton Technical Support with the machine serial number and a clear photo of the currently installed overload and cable size markings on the power cord. Please ensure to disconnect the power before doing this. Keirton will use this

information to confirm that the machine is fitted with the incorrect overload and supply cable, and once confirmed, will provide replacements with installation instructions free of charge, if require

<b>Correct Overload Part#</b>	<b>15-10968</b>
<b>Required Amperage Setting</b>	4.8A
<b>Correct Power Supply Cable Assembly</b>	<b>27-10702</b>
<b>Approved Extension Cord Spec</b>	<b>3.3mm<sup>2</sup> (12 AWG) minimum, 7.6m (25') maximum length</b>

3. **Install the corrected parts:** After the replacement overload and/or cable is received, install the updated parts according to installation instructions provided with the parts. Keirton recommends installing the corrected parts immediately, to reduce the risk of capacitor venting, electrical damage, or unplanned downtime.
